# Council Study Session

<b>Agenda Item</b>	Community Center and Pioneer Hall Schematic Design Update	
<b>From</b>	Scott Fleury PE	Public Works Director
<b>Contact</b>	<a href="mailto:Scott.fleury@ashland.or.us">Scott.fleury@ashland.or.us</a>	
<b>Item Type</b>	Requested by Council <input checked="" type="checkbox"/> Update <input checked="" type="checkbox"/> Request for Direction <input type="checkbox"/> Presentation <input type="checkbox"/>

Reference: Ashland Community Center and Pioneer Hall Improvements

Subject: Facilities Assessments

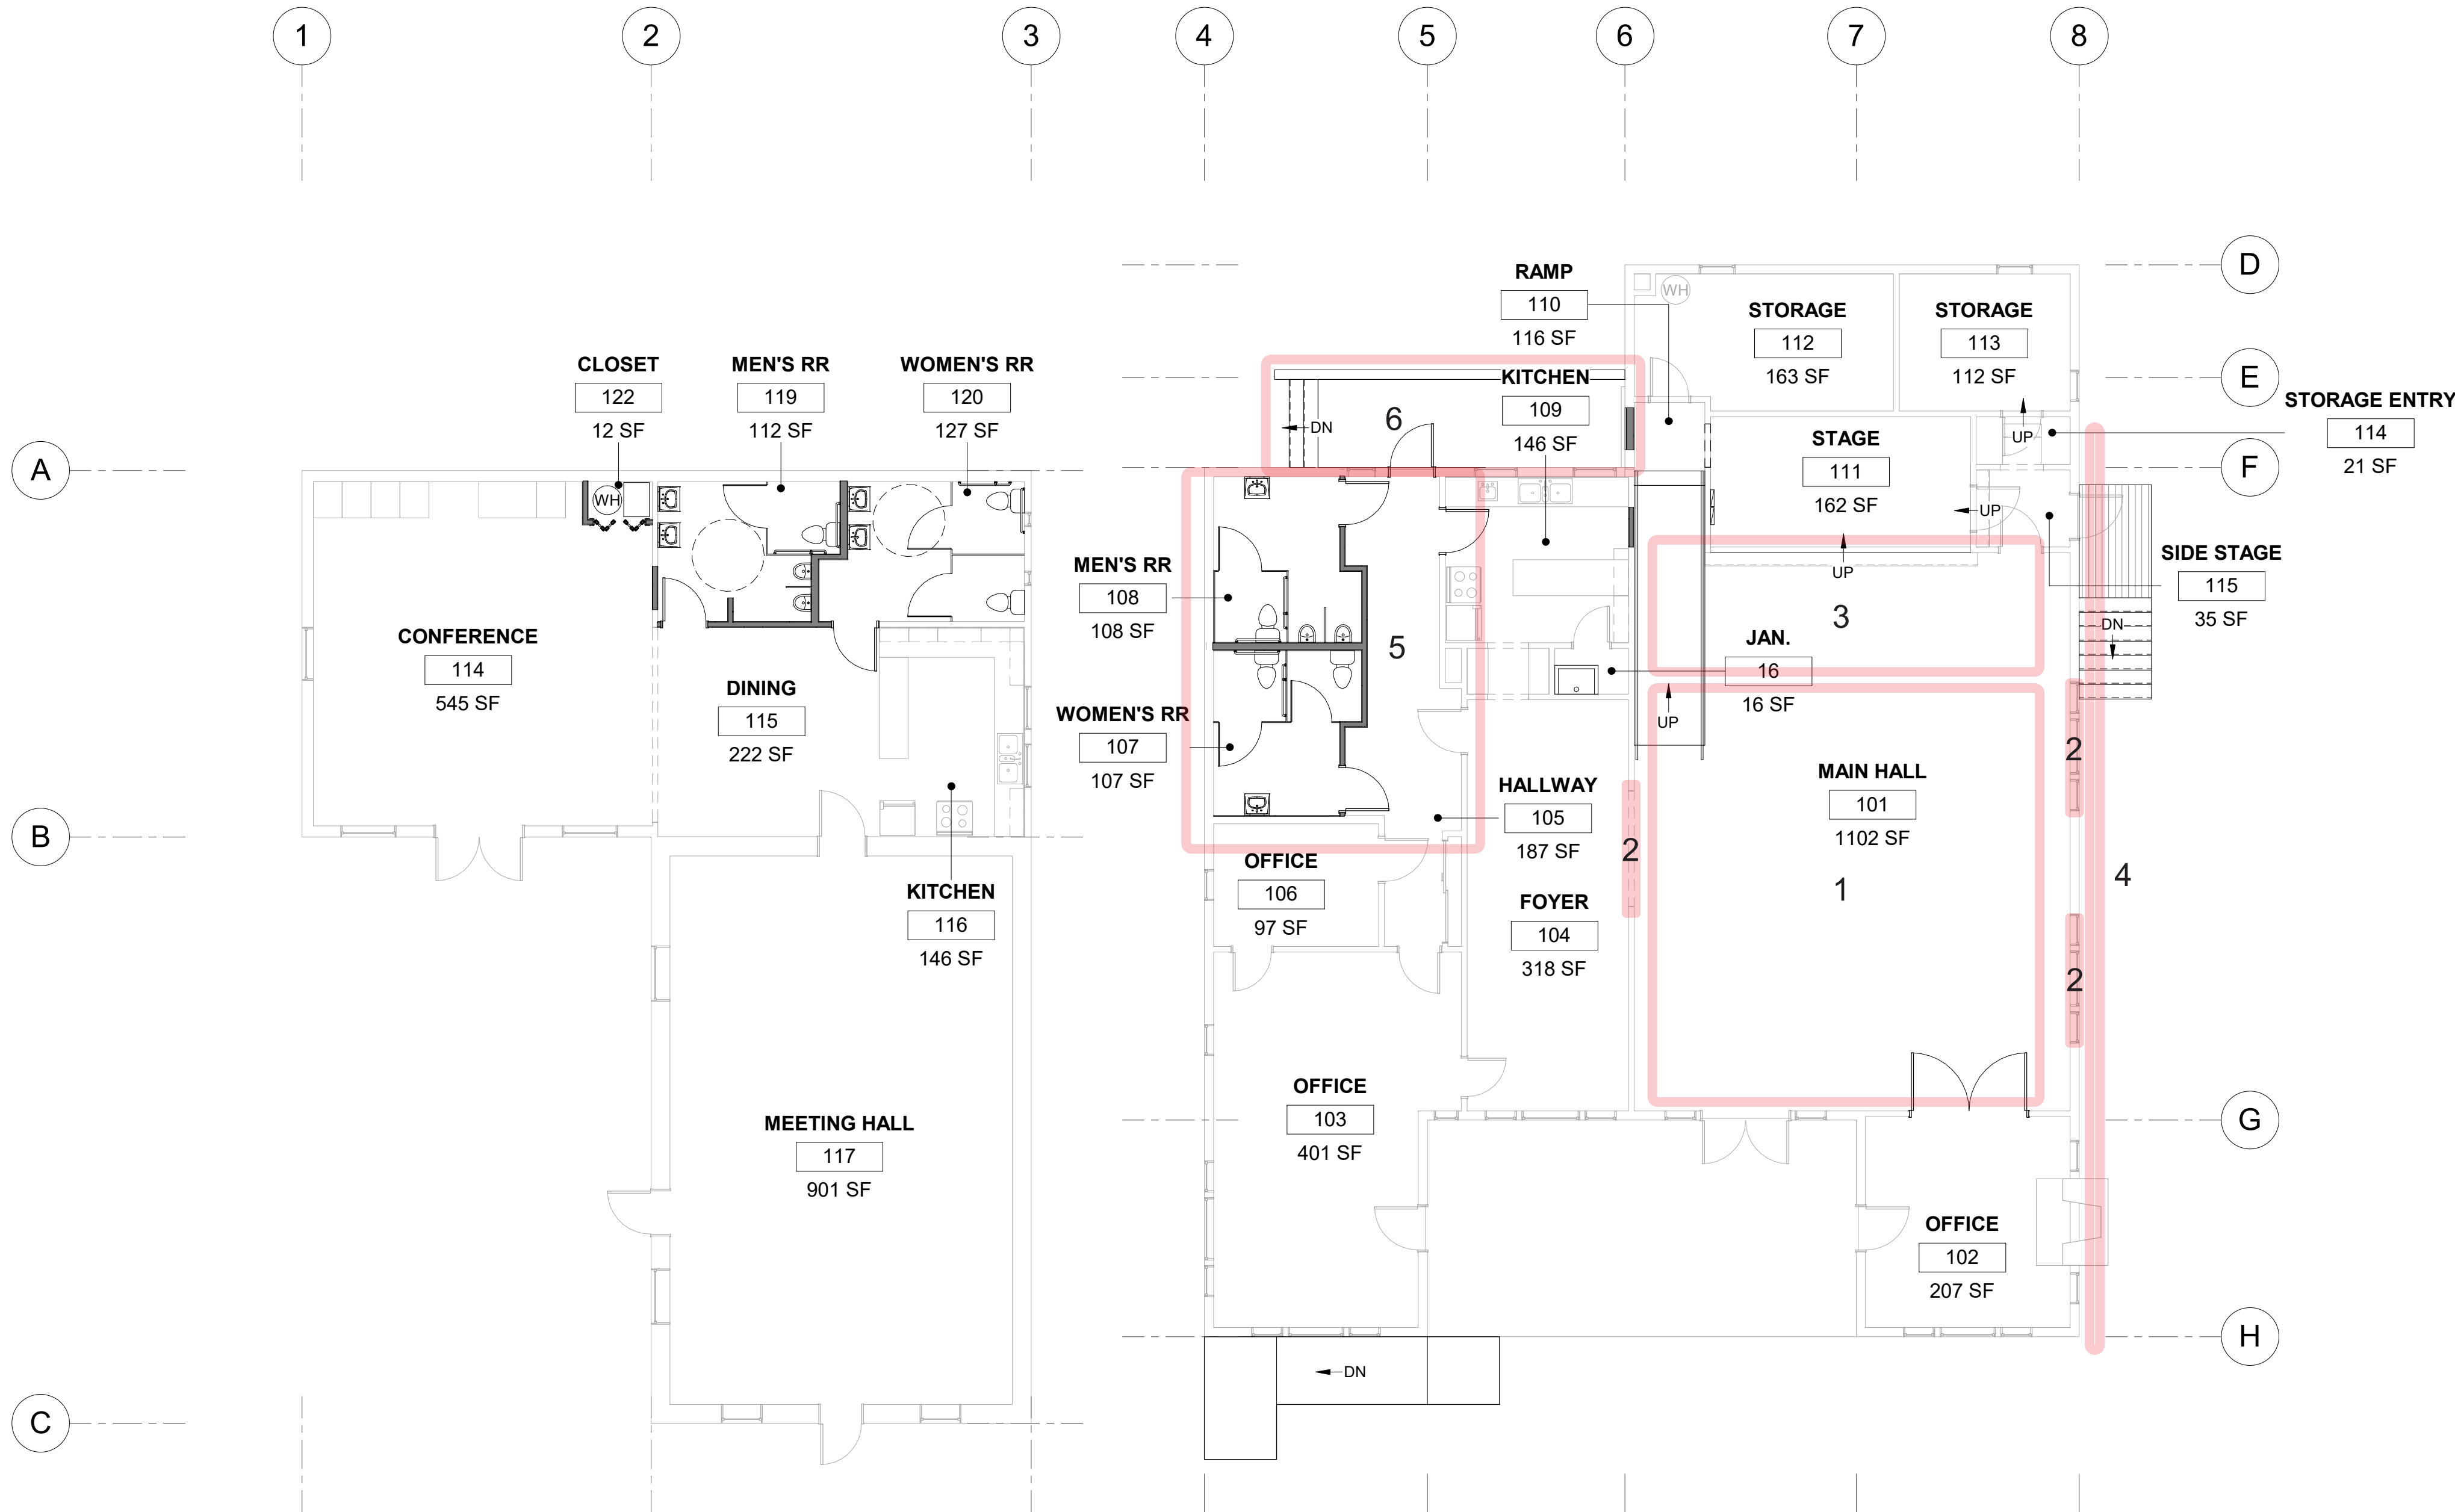
1 FIRST FLOOR PLAN  
A1.1 1/8" = 1'-0"

PRIORITY ONE: STRUCTURAL REPAIRS

- 1 - STRENGTHEN EXISTING MAIN HALL TRUSSES.
  - A. DEMOLISH CEILING FINISHES AND WALL FINISH AS NECESSARY TO ADD NEW STRUCTURAL MEMBERS.
  - B. INSTALL A NEW BOTTOM TRUSS CHORD AND WEBS. NEW BEAMS AND SUPPORT WEBS TO BE GLU-LAM OR LVL. STAIN TO MATCH THE EXISTING TRIM IN MAIN HALL.

- 2 - PROVIDE NEW HEADERS ABOVE THE OPENINGS AROUND MAIN HALL TO SUPPORT STRENGTHENED ELEMENTS.
  - A. DEMOLISH THE FINISH AROUND WINDOW AND PASS THROUGH OPENINGS AS NEEDED TO ADD NEW STRUCTURAL HEADERS.

- B. REPAIR AND REPLACE THE INTERIOR FINISH AND TRIM TO MATCH EXISTING.
  - C. PAINT THE INTERIOR OF MAIN HALL.
- 3 - REPAIR CEILING FRAMING IN ATTIC NEAR PROSCENIUM.

- A. THIS WORK WILL REQUIRE REMOVAL OF CEILING FINISHES BETWEEN NORTH TRUSS AND PROSCENIUM.
  - B. SISTER NEW CEILING FRAMING TO EXISTING FROM TRUSS TO PROSCENIUM WALL PROVIDING ADEQUATE BEARING.

- C. PROVIDE NEW HEADER AND SUPPORTING POSTS AT PROSCENIUM OPENING (STAGE).
- 4 - REPLACE THE NORTH CONCRETE STEM WALL ALONG GRID LINE 8.
  - A. DEMOLISH THE EXISTING CONCRETE POST AND PIER FOUNDATIONS, PROVIDE TEMPORARY SHORING FOR INSTALLATION.

- B. INSTALL NEW CONCRETE STEM WALL AND FOOTING WITH NEW CONNECTION HARDWARE TO WALL ABOVE.
  - C. APPLY STUCCO SCRATCH COAT TO MATCH EXISTING FINISH.

- 5 - NEW CEILING FRAMING TO SUPPORT THE RESTROOM AND HALLWAY RECONFIGURATION.
  - A. RECONFIGURE AND INSTALL NEW CEILING FRAMING TO SUPPORT NEW RESTROOM AND HALLWAY CONFIGURATION.

- B. PREOVIDE NEW HEADERS AND CEILING FRAMING AT RE MOVED STAIRWAY TO SUPPORT NEW FOLD-DOWN ACCESS LADDER.
- 6 - REPLACE REAR EXIT PORCH FRAMING INSTALL RETAIN WALL TO ACCOMODATE NEW EXIT PATH.

- A. REMOVE EXISTING REAR PORCH FRAMING.
  - B. INSTALL NEW RETAIN WALL.
  - C. INSTALL NEW CODE COMPLIANT EXIT STAIRS.

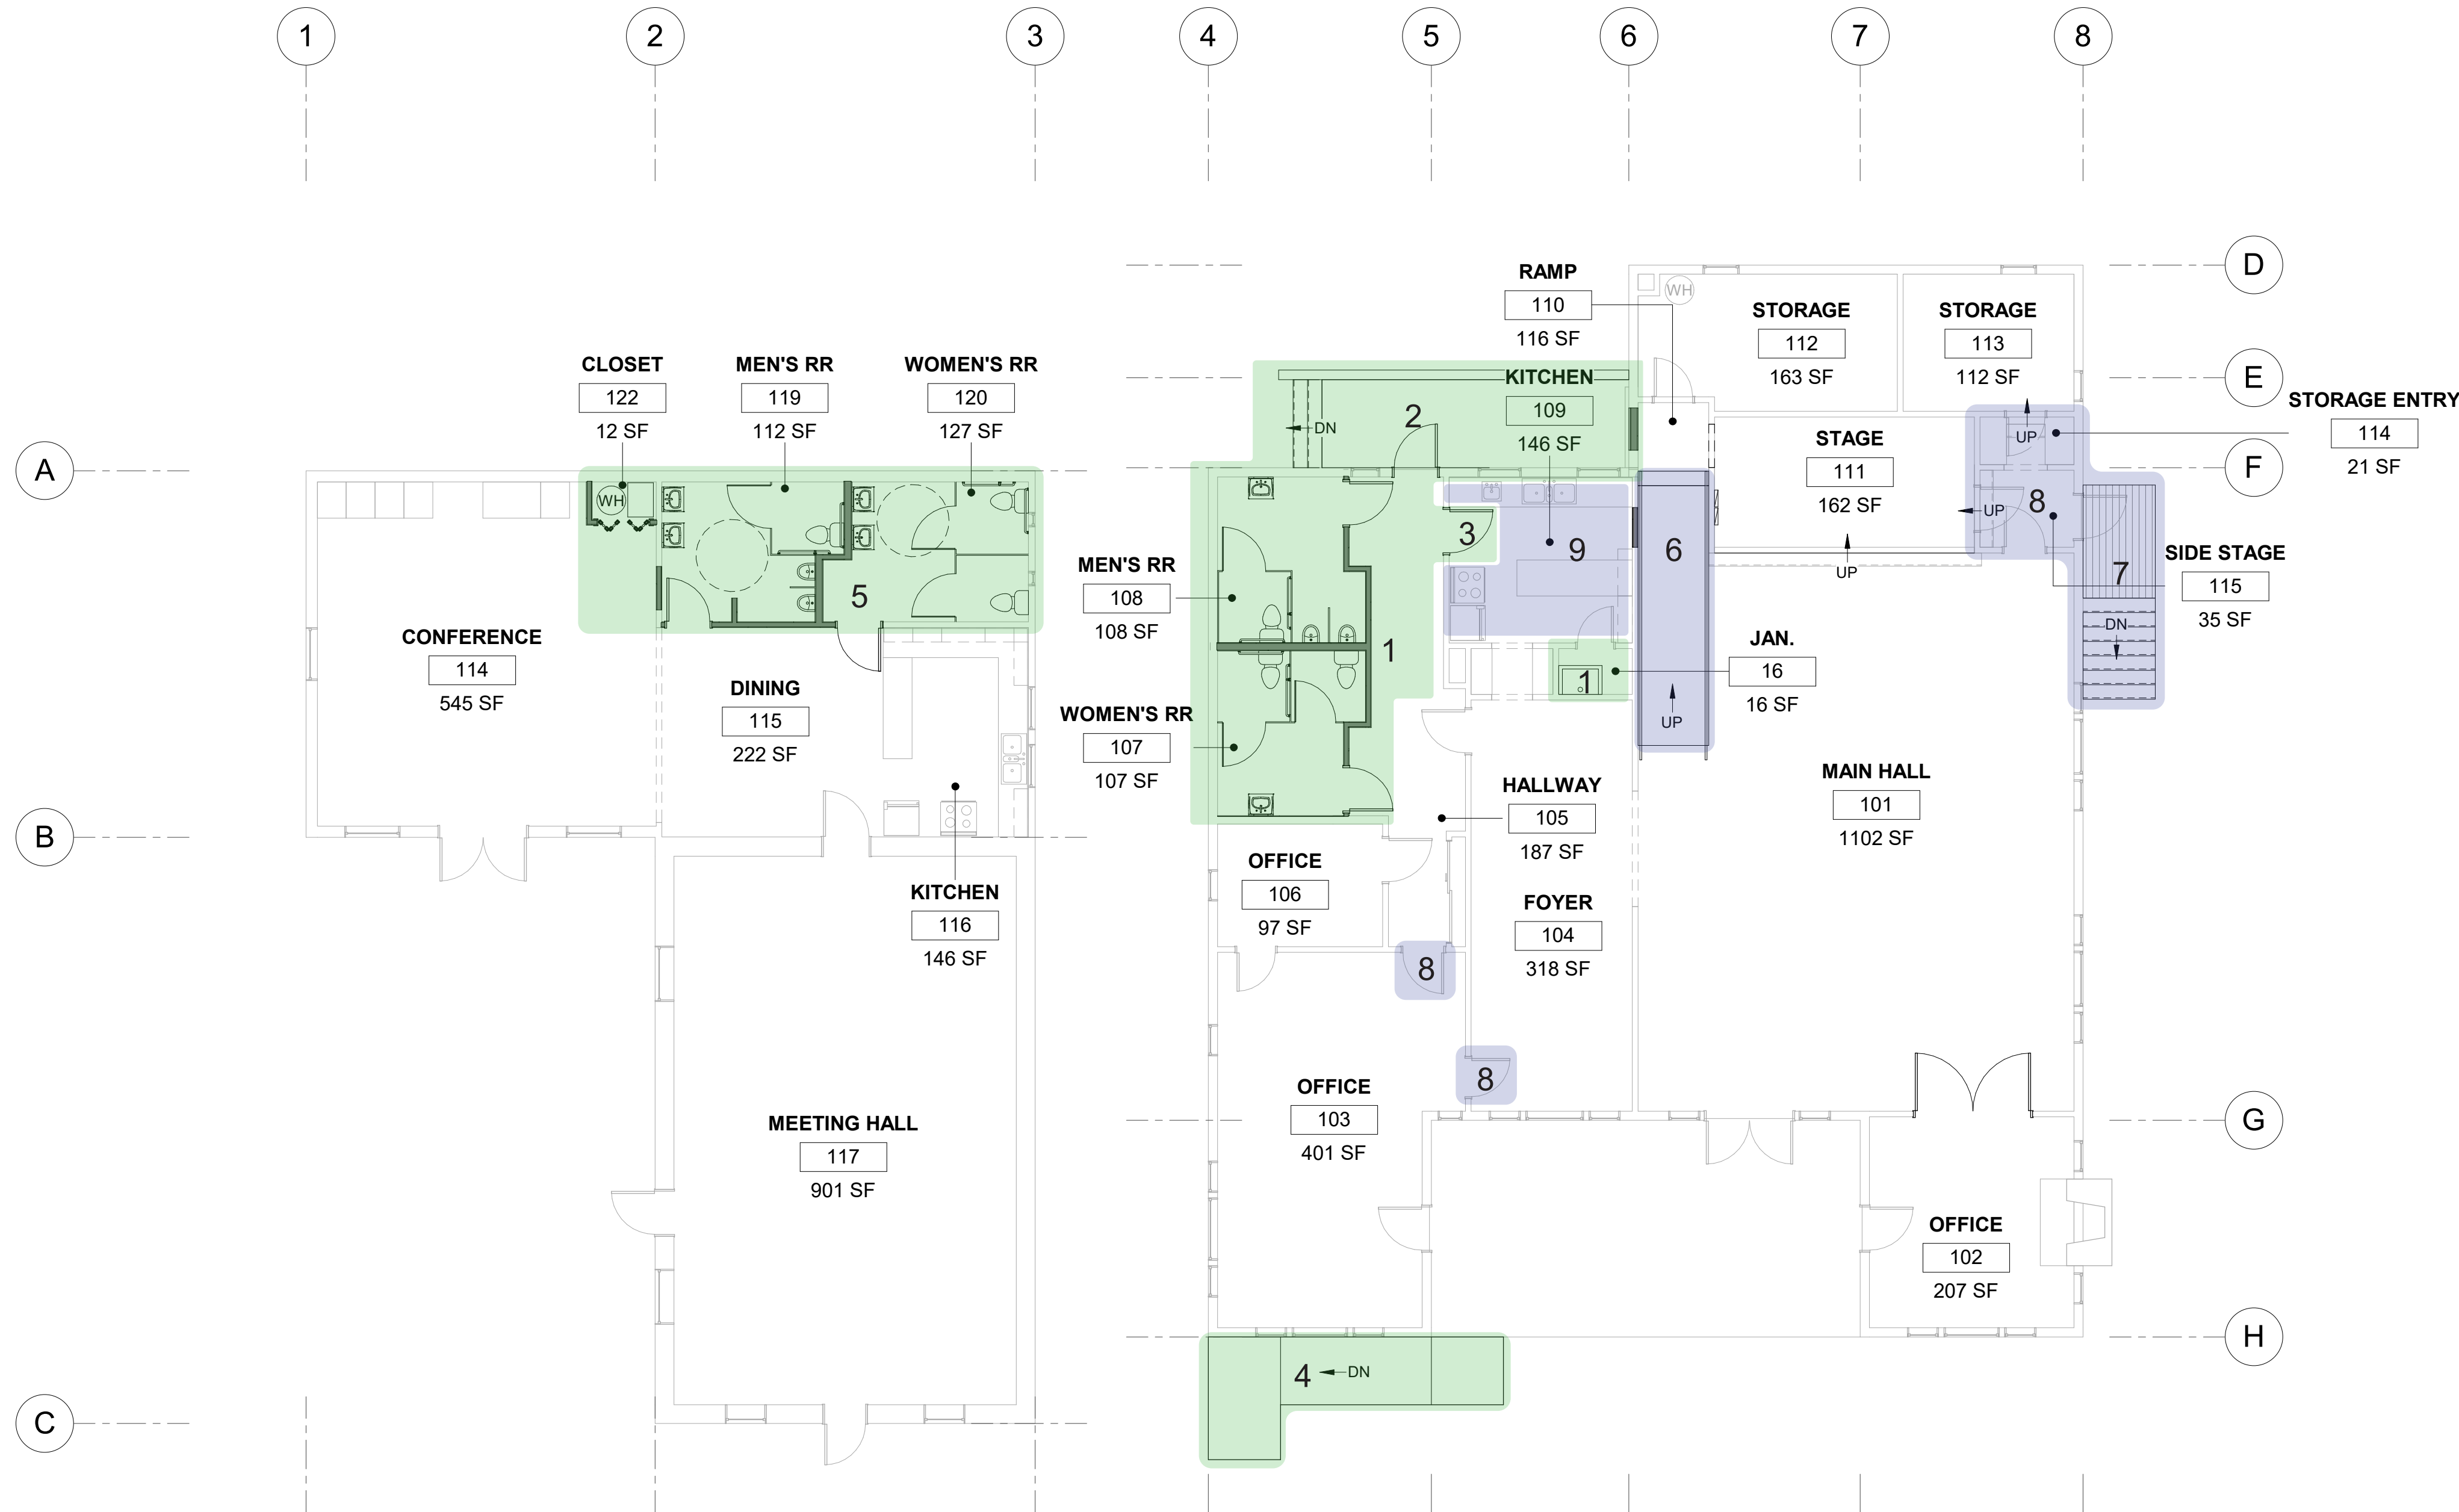
**1 FIRST FLOOR PLAN**  
A1.1 1/8" = 1'-0"

**PRIORITY ONE: CODE DEFICIENCIES**

**PRIORITY TWO: ACCESSIBILITY**

- 1 - DEMOLISH THE EXISTING ATTIC STAIRS, RENOVATE THE EXISTING RESTROOMS TO BE FULLY ACCESSIBLE.
  - A. NEW PLUMBING FIXTURES IN RESTROOMS.
  - i. RECONFIGURATION OF EXISTING PLUMBING IN CRAWL SPACE TO ACCOMMODATE NEW FLOOR PLAN
  - B. NEW FINISHES THROUGHOUT RESTROOMS.
  - C. NEW TOILET PARTITIONS.
  - D. NEW LIGHT FIXTURES AND CEILING EXHAUST FANS.
  - E. NEW ATTIC LADDER ACCESS IN HALLWAY 105
  - F. NEW JANITOR'S CLOSET INTO EXISTING PANTRY IN KITCHEN

- 2 - PROVIDE AN ADEQUATE EXIT PATH OUT OF THE WEST SIDE OF THE BUILDING.
  - A. DEMOLISH THE EXISTING ENCLOSED PATIO AND ROOF.
  - B. PROVIDE A NEW CONCRETE RETAINING WALL.
  - C. NEW CODE COMPLIANT STAIRS
  - D. NEW 3'-0" WIDE EXTERIOR DOOR
  - E. PATCH EXTERIOR SIDING
  - F. PROVIDE EXTERIOR PATIO LIGHT

- 3 - PROVIDE A NEW 3'-0" DOOR INTO THE KITCHEN, REVERSE THE SWING OF THE DOOR.
  - A. DEMOLISH EXISTING DOOR AND FRAME
  - B. PROVIDE NEW DOOR AND FRAME.

- 4 - PROVIDE NEW ACCESSIBLE RAMP AT THE ENTRANCE OF THE COMMUNITY CENTER.
  - A. REMOVE LANDSCAPING AND NEEDED.
  - B. PROVIDE NEW CONCRETE ACCESSIBLE RAMP AT THE SOUTH EAST CORNER OF THE BUILDING.

- 5 - RENOVATE THE EXISTING RESTROOMS TO BE FULLY ACCESSIBLE.
  - A. REMOVE EXISTING OFFICE TO ACCOMMODATE NEW RESTROOMS
  - B. NEW PLUMBING FIXTURES IN RESTROOMS.
  - i. RECONFIGURATION OF EXISTING PLUMBING IN CRAWL SPACE TO ACCOMMODATE NEW FLOOR PLAN
  - C. NEW TOILET PARTITIONS.
  - D. NEW LIGHT FIXTURES AND CEILING EXHAUST FANS.

- 6 - PROVIDE RAMP ACCESS TO THE EXISTING STAGE.
  - A. DEMOLISH THE EXISTING WALL, DOOR, AND STAIR.
  - B. RELOCATE EXISTING ELECTRICAL PANEL TO OTHER SIDE OF WALL ON GRID LINE 6.
  - C. NEW ACCESSIBLE RAMP WITH HAND RAILS.
  - D. WIDEN THE STAGE ACCESS OPENING TO 3'-0". PROVIDE NEW WOOD TRIM TO MATCH THE EXISTING.

- 7 - REBUILD THE WOOD STAIRS AND LANDING ON THE NORTH SIDE OF THE BUILDING TO BE FULLY ACCESSIBLE.

- 8 - WIDEN THE OPENINGS IN THESE AREAS TO BE A MINIMUM OF 3'-0" WIDE.

- 9 - RENOVATE THE KITCHEN TO BE FULLY ACCESSIBLE.
  - A. DEMOLISH EXISTING CASEWORK TO RELOCATE THE EXISTING RANGE AND REFRIGERATOR. PROVIDE A 5' DIAMETER TURNING RADIUS, AND REPLACE THE CASEWORK TO HAVE A 34" TALL COUNTER TOP.
  - i. RECONFIGURATION OF EXISTING PLUMBING AND ELECTRICAL.

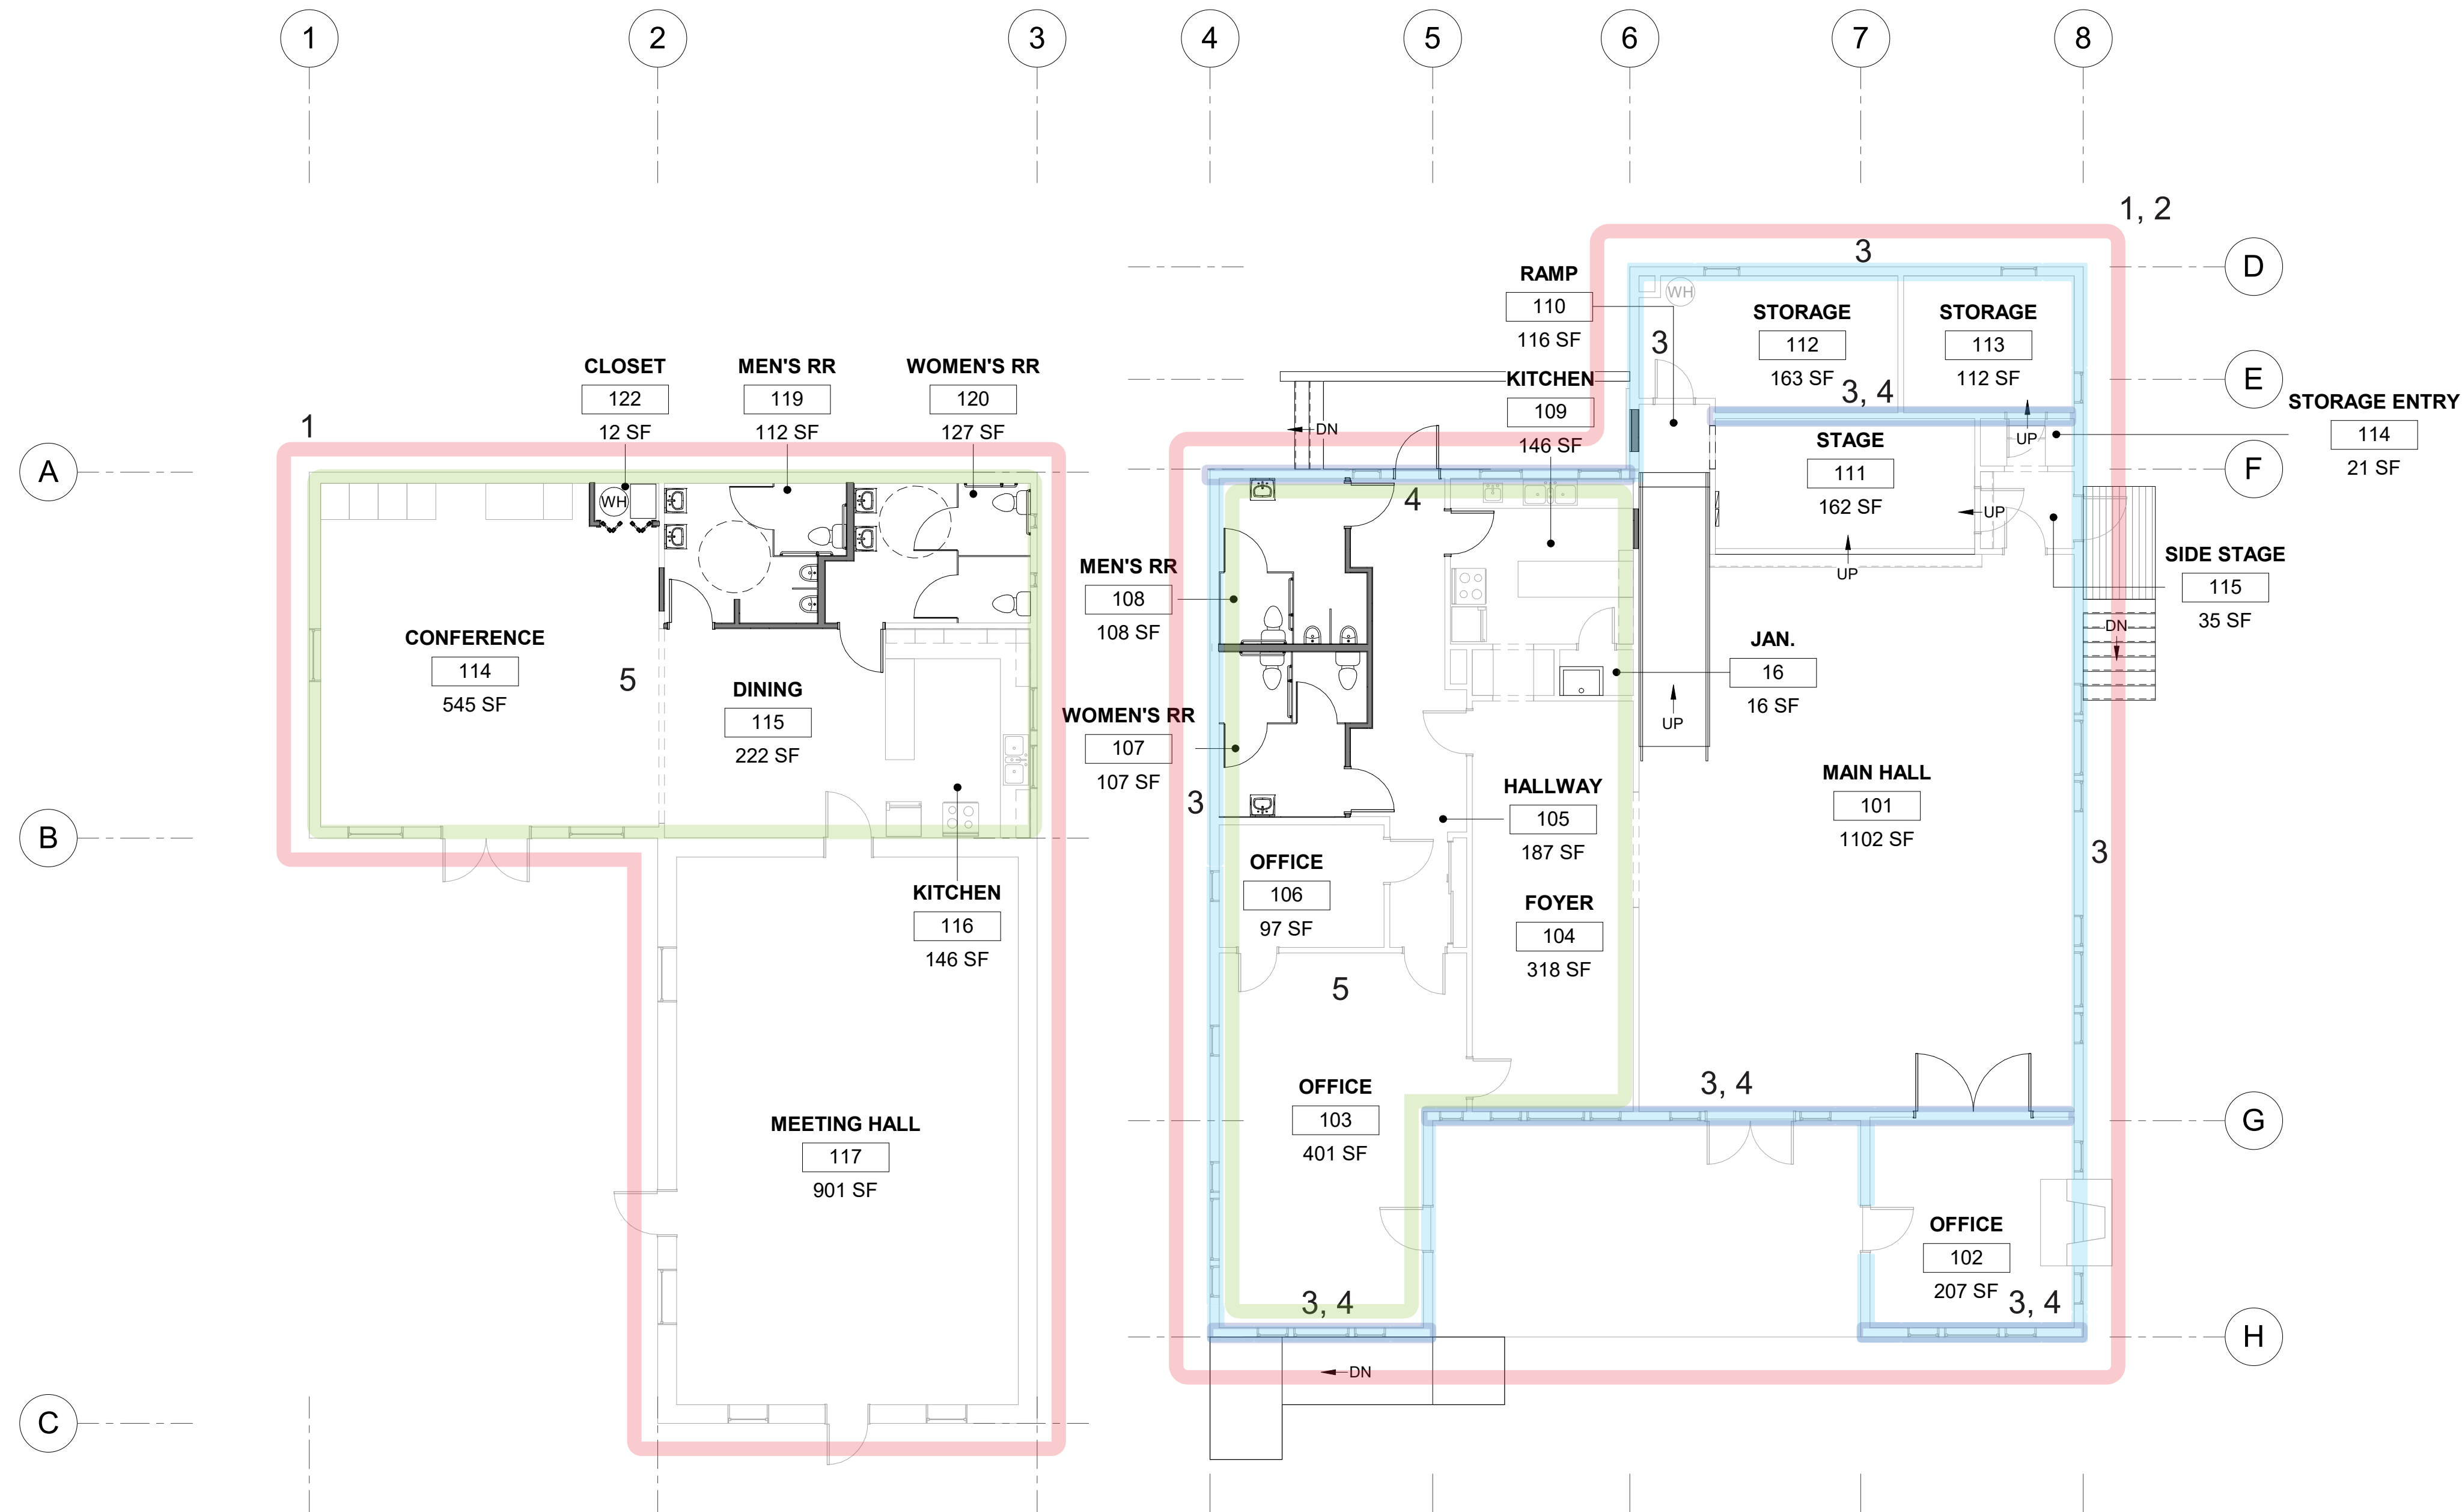
1 FIRST FLOOR PLAN  
A1.1 1/8" = 1'-0"

**PRIORITY THREE: STRUCTURAL CODE DEFICIENCIES**

- 1 - STRENGTHEN EXISTING ROOF FRAMING TO SUPPORT CODE LEVEL LOADS.
  - A. SISTER NEW ROOF FRAMING ELEMENTS TO EXISTING FRAMING.
  - B. PROVIDE ADDITIONAL PONY WALLS IN ATTIC SPACE TO REDUCE SPANS OF EXISTING FRAMING.

- 2 - PROVIDE PLYWOOD SHEATHED ROOF DIAPHRAGM TO SUPPORT CODE LATERAL FORCES.
  - A. REMOVE EXISTING ROOFING, INSTALL NEW CONNECTION HARDWARE AND PLYWOOD SHEATHING.

- B. INSTALL NEW COMPOSITION ROOF.
- 3 - PROVIDE FOUNDATIONS AT SHEAR WALLS TO SUPPORT TRANSFER OF LATERAL FORCES.
  - A. PROVIDE TEMPORARY SHORING, REMOVE EXISTING POST AND PIER FOUNDATION SYSTEMS AT DISCRETE LOCATIONS FOR INSTALL OF NEW CONCRETE STEM WALL AND FOOTINGS AND ANCHORAGE TO EXISTING WALLS.

- 4 - PROVIDE NEW PLYWOOD SHEATHING AT EXISTING WALLS FOR ADEQUATE CAPACITY OF CODE LATERAL FORCES.
  - A. REMOVE EXISTING INTERIOR OR EXTERIOR FINISHES, INSTALL NEW CONNECTION HARDWARE AND PLYWOOD SHEATHING.

- B. TO PROVIDE ADEQUATE IN-PLANE LATERAL CAPACITY SELECT WINDOWS WILL REQUIRE INFILL WITH NEW SHEAR WALLS.
- 5 - PROVIDE ADDITIONAL FLOOR SUPPORT BEAMS FOR ADEQUATE LIVE LOAD CAPACITY OF FLOOR FRAMING.

- A. PROVIDE NEW POST AND BEAM SYSTEM IN CRAWL SPACE TO REDUCE SPAN OF EXISTING FLOOR FRAMING.

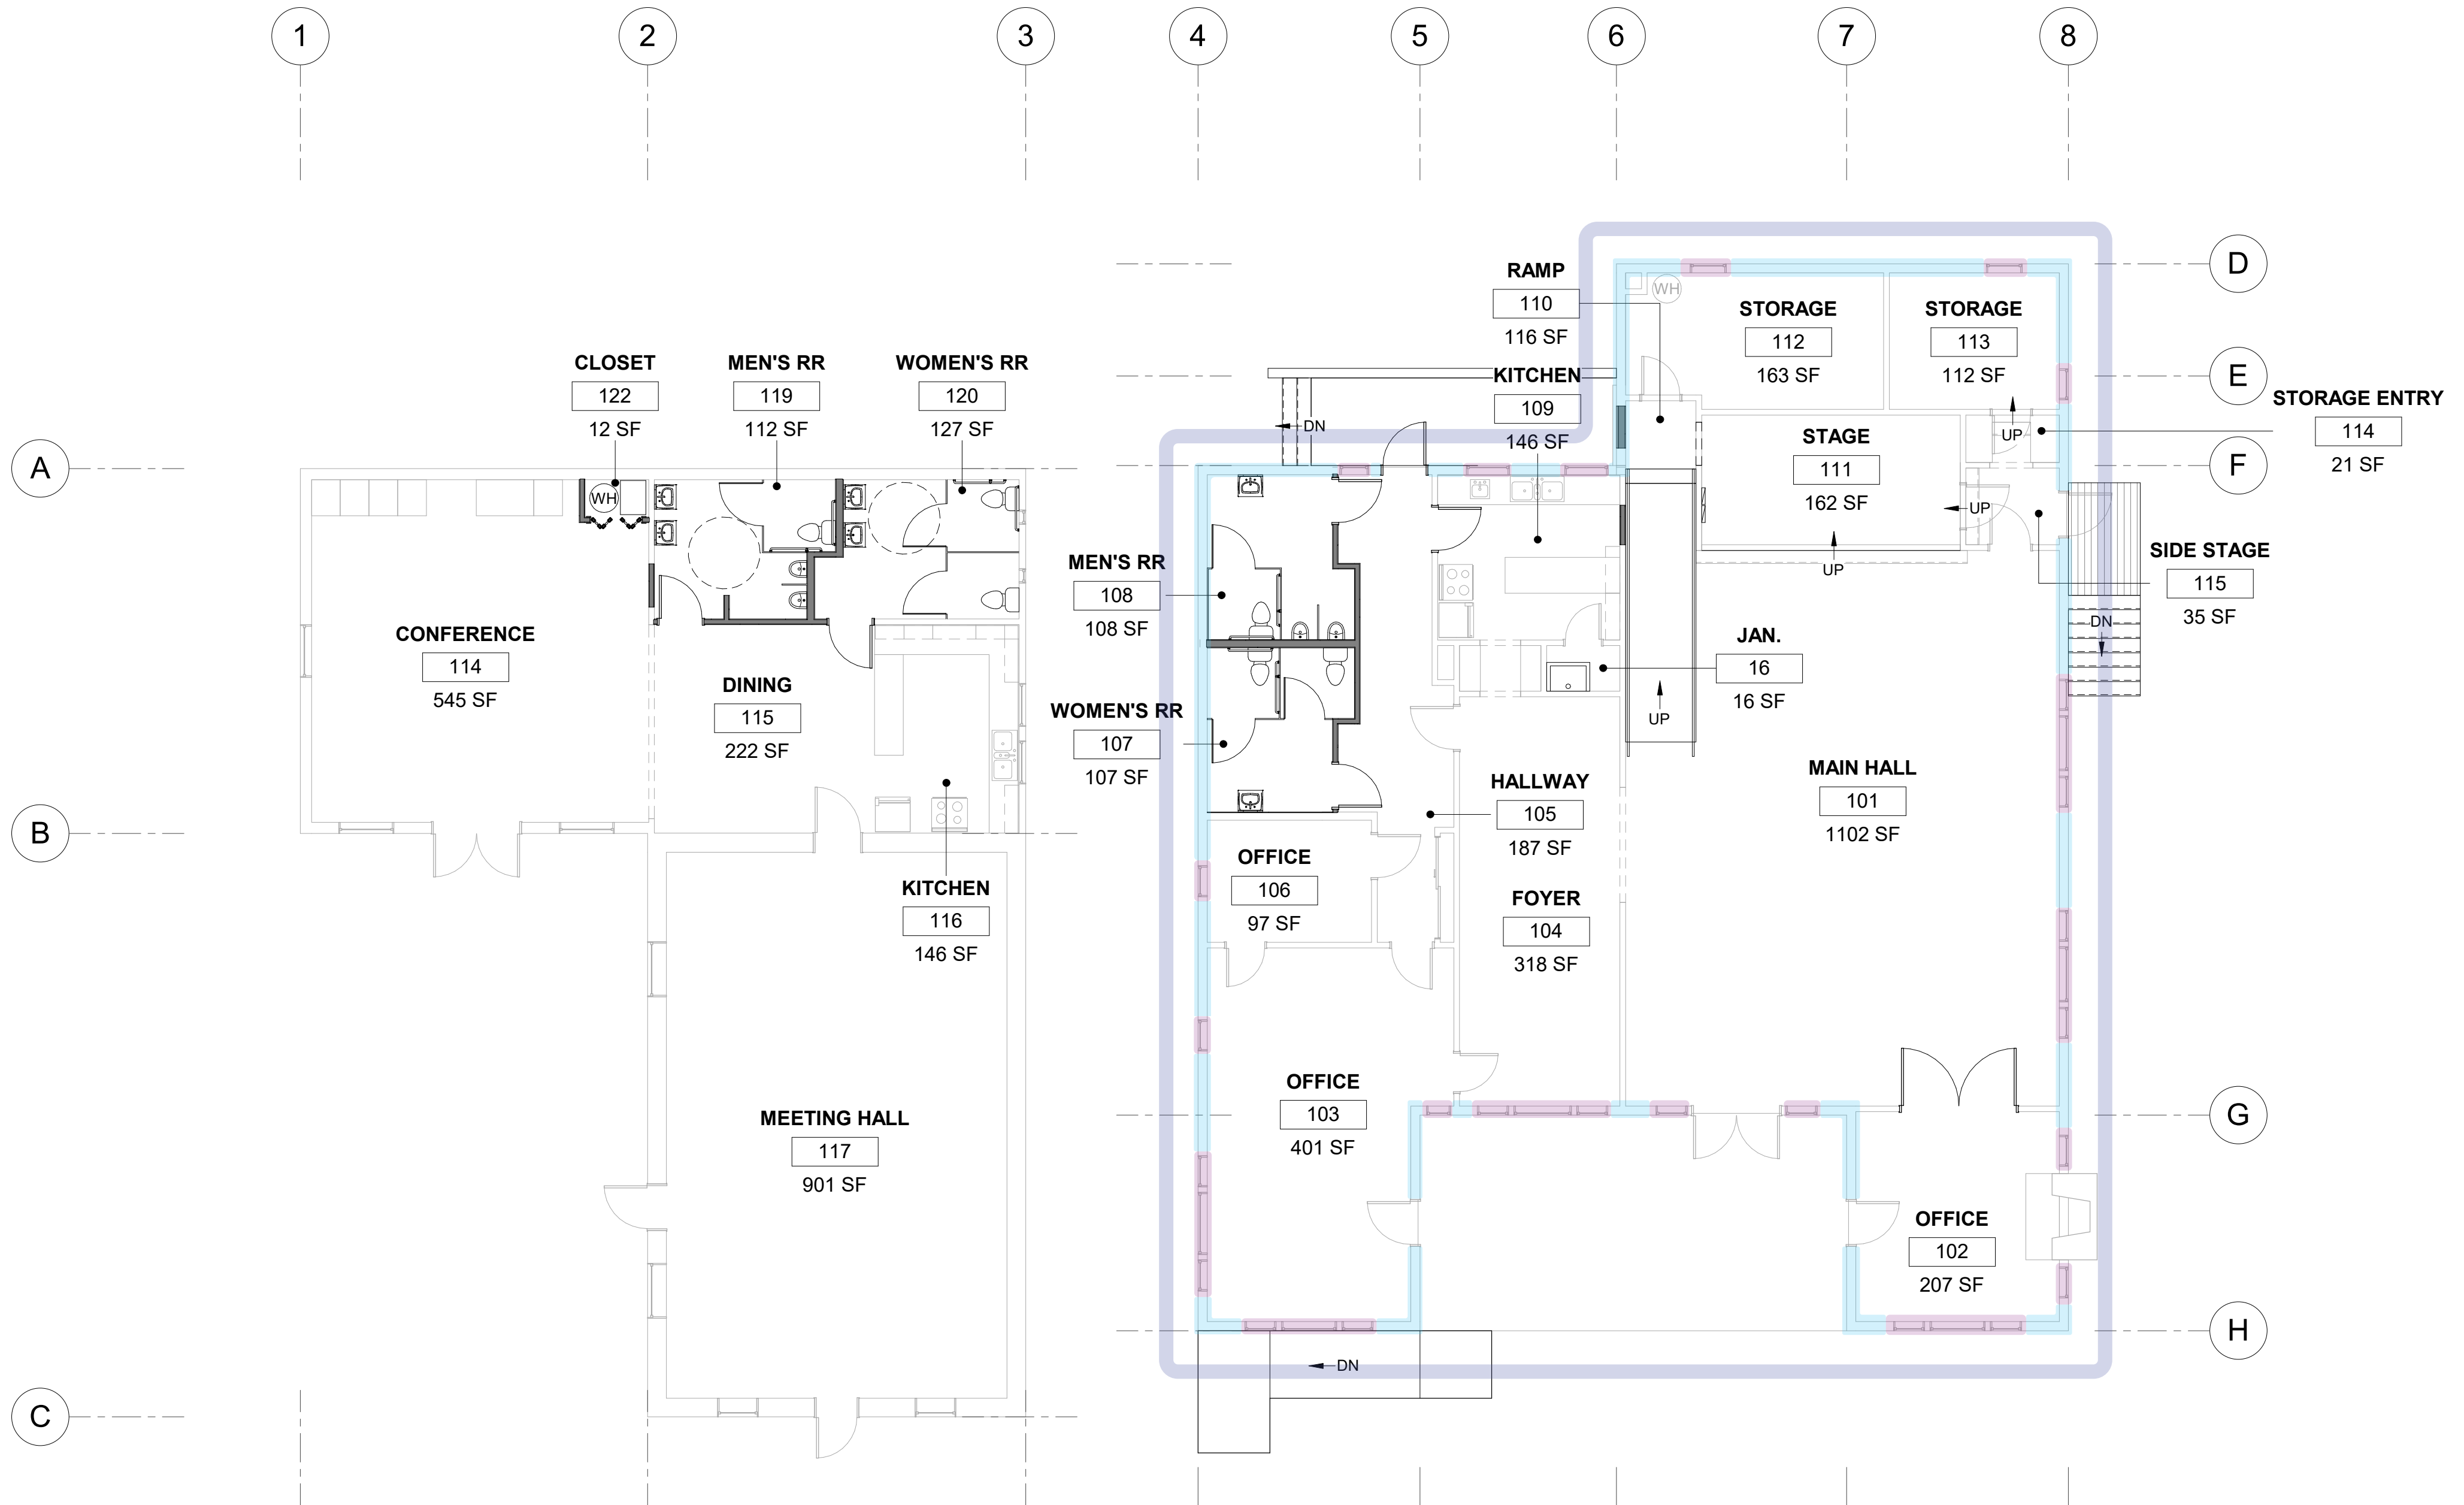
1 FIRST FLOOR PLAN  
A1.1 1/8" = 1'-0"

**PRIORITY FOUR: MECHANICAL SYSTEM UPGRADES**

**PRIORITY FIVE: THERMAL PERFORMANCE**

- 1 - UPGRADE THE EXISTING HEATING AND COOLING SYSTEMS IN THE COMMUNITY CENTER.
  - A. ALONG SIDE THE HVAC UPGRADES TO THE BUILDING, UTILITIES SUCH AS ELECTRICAL SERVICE AND PLUMBING MAY NEED TO BE UPGRADED. THIS MAY INCLUDE INCREASING THE SERVICE SIZE TO THE BUILDING, UPGRADE THE EXISTING ELECTRICAL PANELS TO NEW 3 PHASE PANEL, AND UPDATING THE SEWER/PLUMBING LINES IN THE BUILDING TO ACCOMMODATE THE NEW FIXTURES.
- 2 - REPLACE LIGHT FIXTURES WITH NEW ENERGY EFFICIENT LED'S.
  - A. SIMILAR TO THE HVAC UPGRADES, WHEN REPLACING THE EXISTING LIGHT FIXTURES, NOW WOULD BE THE TIME TO REPLACE ANY OUTDATED WIRING OR REMOVE ANY ABANDONED WIRING AND CONDUIT.

- 1 - REPLACE THE EXTERIOR WINDOWS WITH NEW VINYL FRAME WINDOWS WITH INSULATED GLAZING UNITS.
- 2 - REPLACE THE ROOF INSULATION.
  - A. OPTION 1, REPLACE WITH NEW BLOWN-IN INSULATION.

- 1. REMOVE EXISTING BLOWN-IN INSULATION. REPLACE WITH NEW. THIS OPTION MAY REMOVE THE AVAILABLE STORAGE IN THE ATTIC.
  - B. OPTION 2, SPRAY FOAM INSULATION ON UNDERSIDE OF ROOF STRUCTURE.

- 1. REMOVE EXISTING BLOWN-IN INSULATION.
    - 2. USE 2 POUND, HIGH DENSITY, CLOSED CELL SPRAY FOAM INSULATION ON THE UNDER SIDE OF THE ROOF STRUCTURE. THIS SOLUTION REMOVES THE REQUIREMENT TO VENTILATE THE ATTIC SPACE. ALLOWS FOR MORE ATTIC STORAGE.

- 3- NEW INSULATION IN EXTERIOR WALLS.
  - A. OPTION 1, REPLACE THE EXTERIOR WALL INSULATION FROM THE INTERIOR WITH NEW SPRAY FOAM INSULATION.
    - 1. REMOVE THE EXISTING BLOWN-IN INSULATION. AT EACH STUD BAY, DRILL A HOLE AT THE TOP OF WALL, UNDER THE TOP PLATE. FILL CAVITY WITH NEW 2 POUND, HIGH DENSITY, CLOSED CELL, SPRAY FOAM INSULATION.

- B. OPTION 2, REPLACE THE EXTERIOR WALL INSULATION FROM THE INTERIOR WITH NEW BATT INSULATION.
    - 1. REMOVE THE EXISTING BLOWN-IN INSULATION. REMOVE THE EXISTING INTERIOR FINISHES TO ALLOW FOR INSTALLING THE NEW BATT INSULATION. DEPENDING ON THE DEPTH OF THE EXISTING STUDS, THIS CAN BRING THE BUILDING UP TO CURRENT CODE.

- 2. WALL FINISH REPLACEMENT WILL DEPEND OF THE DESIRED LEVEL OF FINISH. IN MOST AREAS OF THE BUILDING, THE WALL FINISH IS LATH AND PLASTER. THIS IS A MORE EXPENSIVE SOLUTION COMPARED TO DRYWALL WITH A SANDED PAINT FINISH TO IMITATE THE PLASTER LOOK. IN ALL ROOMS WHERE THE FINISH IS REMOVED, WE WOULD INDICATE THE WHOLE ROOM TO RECEIVE A NEW COAT OF PAINT TO HAVE A SIMILAR FINISHED APPEARANCE. NEW TRIM TO MATCH THE EXISTING WOULD BE ADDED TO THE OPENINGS. THIS OPTION HAS A LOT OF VARIABLES AND WOULD BE THE MOST EXPENSIVE SOLUTION DUE TO ACCESSING THE EXTERIOR WALLS. REMOVING CASEWORK, FINISHES, TRIM, AND WALL MOUNTED FIXTURES TO ACCOMPLISH THE WORK.
